What is a Temperature/Pressure Relief (TPR) Valve?

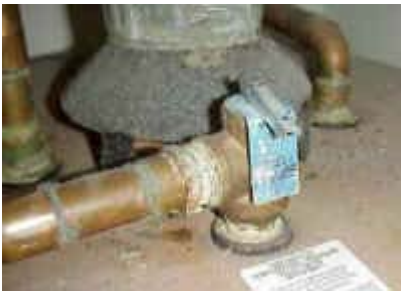
Figure 1: Shows a typical Temperature/Pressure Relief (TPR) Valve installation on a gas water heater.

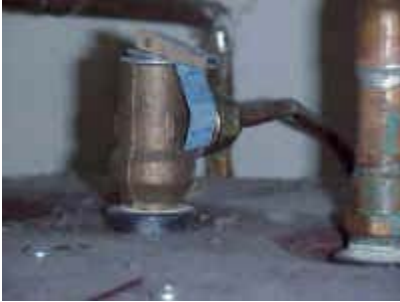
Figure 2: Shows a TPR Valve that has been fitted with a discharge pipe that is smaller than the size of the valve outlet. This is a common defect that is strictly prohibited because smaller discharge pipes restrict the flow of the pressurized water released by the valve. This creates a dangerous build-up of pressure at the point of discharge that can cause the tank to explode.

Section P2803.6.1 requires that the TPR valve is fitted with a discharge pipe that provides the same size opening as the valve outlet itself.
